Karst Invertebrate Survey

Technical Report

**KARST INVERTEBRATE TECHNICAL REPORT
FOR US 281 FROM LOOP 1604 TO BORGFELD ROAD, BEXAR
COUNTY, TEXAS**

28 December 2011

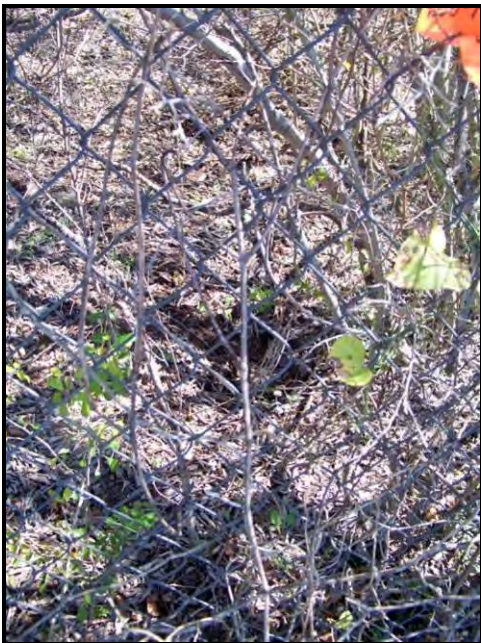
281-004, closed depression This is a closed depression that is situated on private property where right of entry was not granted. It is just across a fence line at the base of a persimmon tree (Figure 4). The feature is 0.7 m (2.3 ft) long, 0.5 m (1.6 ft) wide, and 0.25 m (0.8 ft) deep. It may be a solutional sinkhole, or it could be an animal burrow. It was recommended for excavation, but no right of entry was available.

Figure 4. View of feature 281-004 through fence.

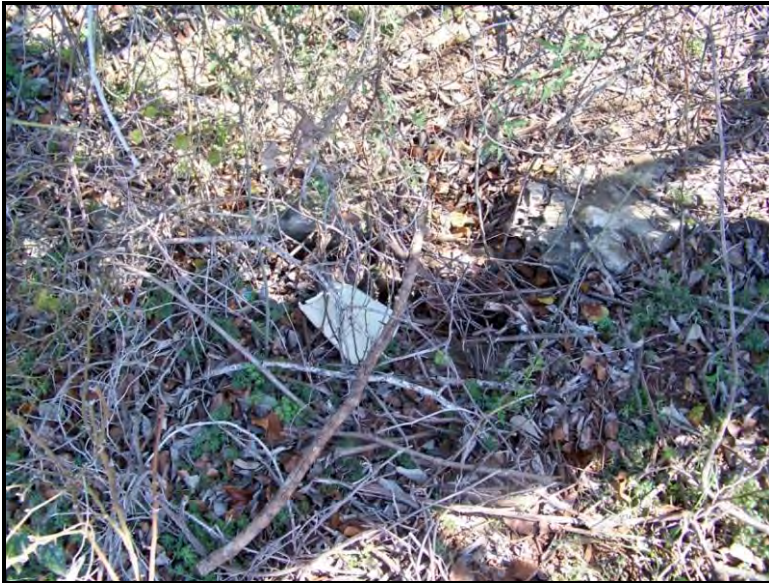
281-005, non-karst closed depression/animal burrow This closed depression is mostly in the ROW, but is crossed by a fence and is partially on private property (Figure 5). A hackberry tree is growing out of one side of it. It is 1.5 m (4.9 ft) long, 0.7 m (2.3 ft) wide, and 0.2 m (0.7 ft) deep. Excavation was conducted on 10 September 2010 for 1.5 person-hours and 0.15 m³ (5.3 ft³) of material was removed. It was determined to be a burrow made by animals exploiting the roots of the hackberry tree rather than a karst feature

Figure 5. Overview of feature 281-005. Chain link fence can be seen crossing the feature.

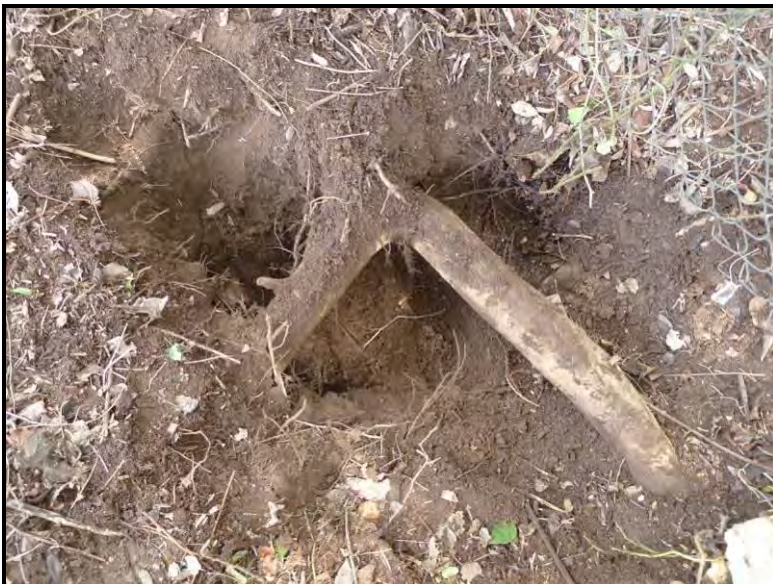
Figure 6. Feature 281-005 after excavation. It is a burrow made by animals exploiting a root system.

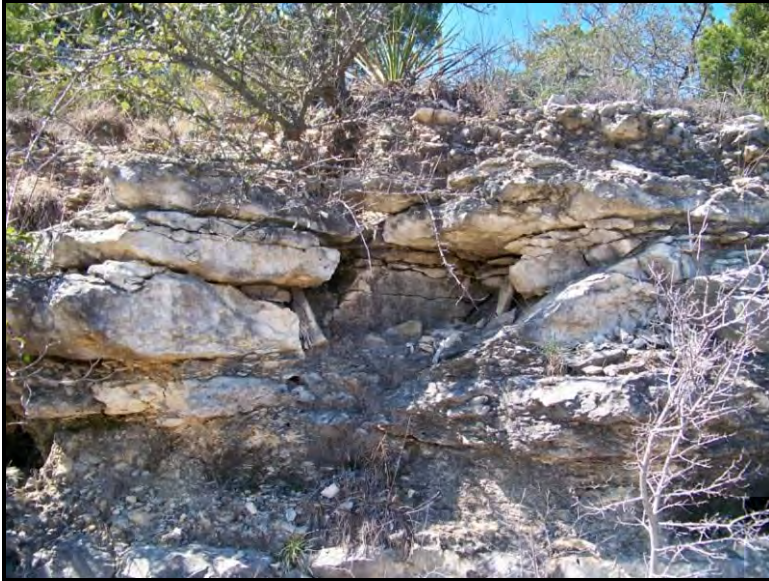
281-006, enlarged fracture This feature is in the road cut on the west side of US 281. The entrance to it is 0.8 m (2.6 ft) wide, 0.4 m (1.3 ft) high, and it extends into the road cut for 1 m (3.3 ft) (Figure 7). It is an enlarged fracture with no infill (Figure 8). Harvestmen (*Leiobunum townsendi*) were observed in this feature. This feature was not recommended for excavation (Table 1).

Figure 7. Overview of feature 281-006.

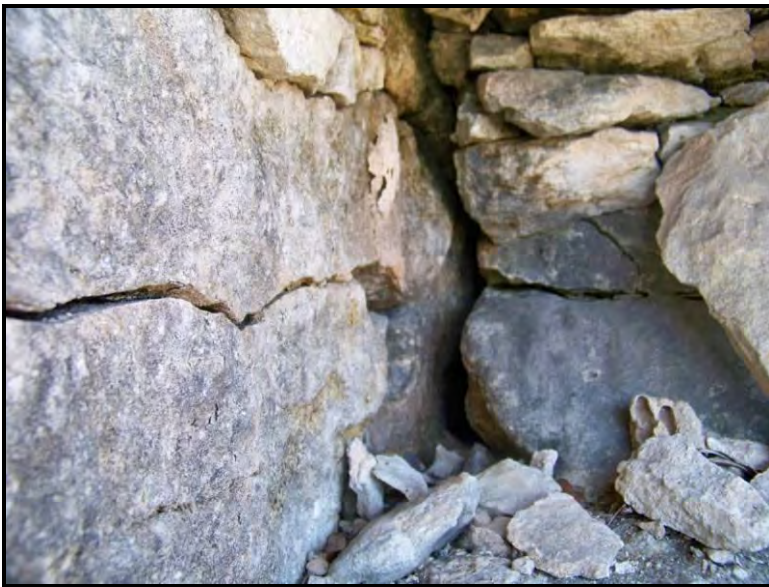
Figure 8. Interior of feature 281-006.

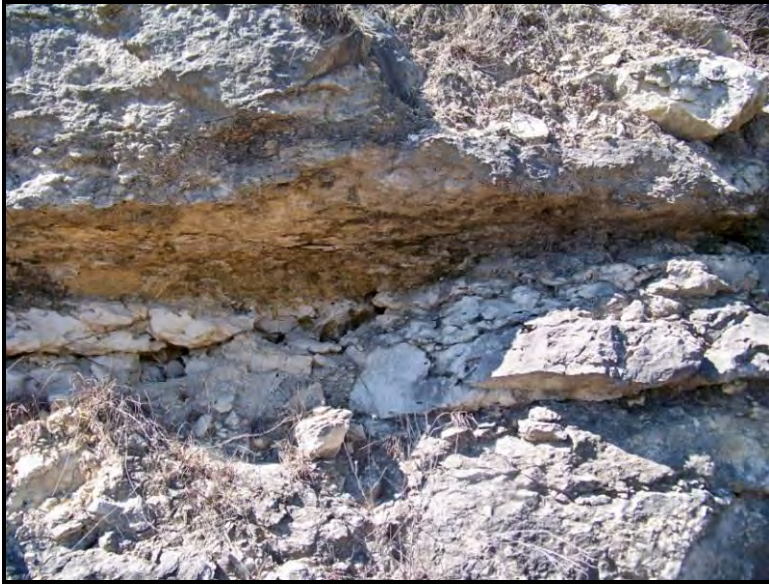
281-007, solution cavity/enlarged bedding plane This feature is situated in the road cut on the west side of US 281. The entrance to the feature is 0.7 m (2.3 ft) wide, 0.5 m (1.6 ft) high, and it extends into the road cut for 0.5 m (1.6 ft) (Figure 9). It is an enlarged bedding plane with no infill (Figure 10). A list of fauna encountered in 281-007 can be found in Table 3. This feature was not recommended for excavation (Table 1).

Figure 9. Overview of feature 281-007.

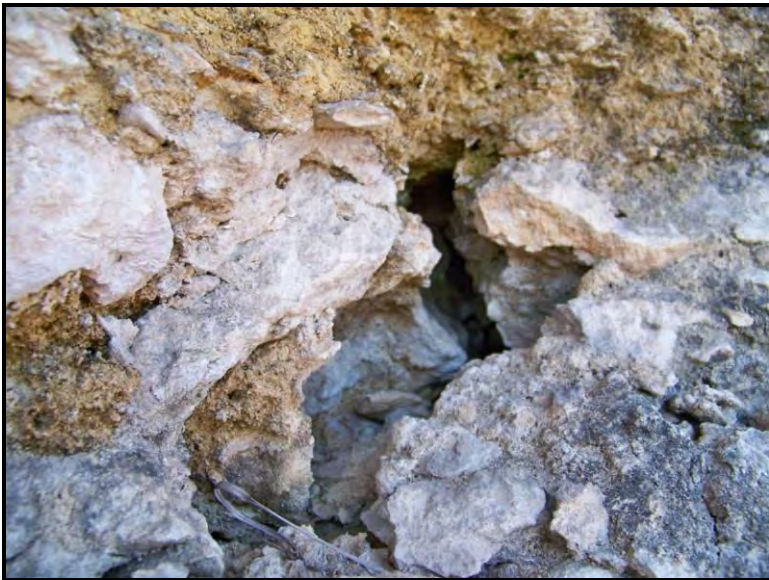
Figure 10. Interior of feature 281-007.

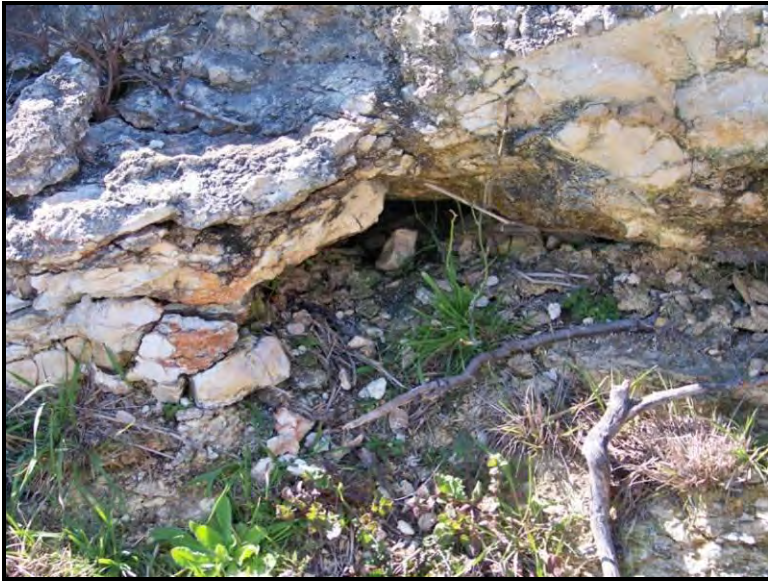
281-008, solution cavity/enlarged bedding plane This is an enlarged bedding plane feature in the road cut on the west side of US 281 (Figure 11). The entrance is 0.4 m (1.3 ft) wide, 0.1 m (0.3 ft) high, and it extends into the road cut for at least 1.5 m (4.9 ft) (Figure 12). It is developed in pulverulitic limestone and has no sediment infill. This feature was not recommended for excavation (Table 1).

Figure 11. Overview of feature 281-008.

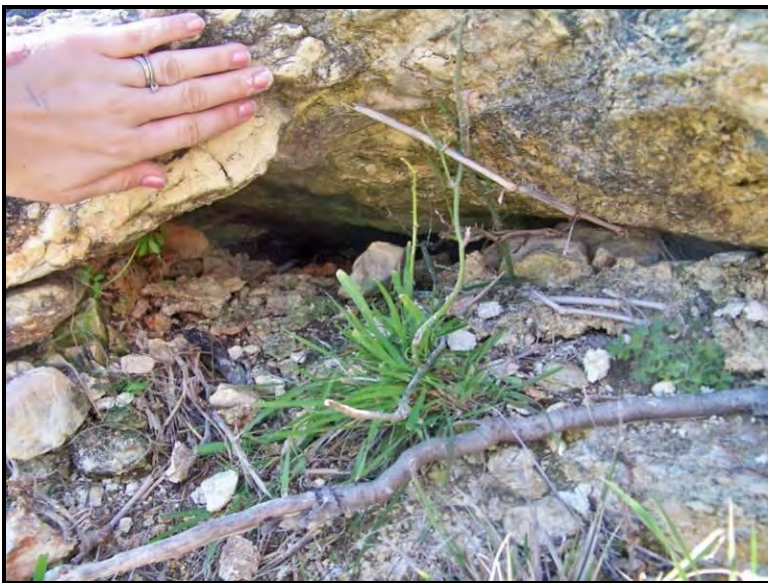
Figure 12. Interior of feature 281-008.

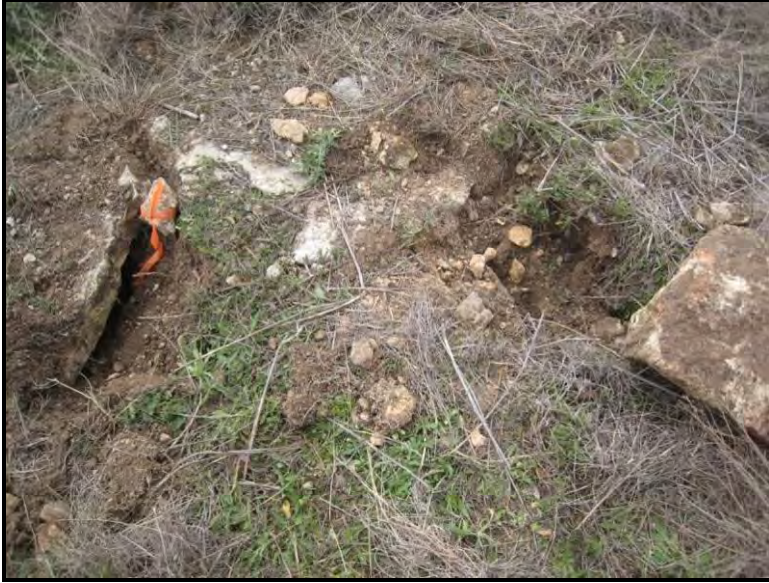
281-009, closed depressions This is a pair of closed depressions on private property on the west side of US 281 (Figure 13). The feature measures 1.5 by 1 m (4.9 ft by 3.8 ft), and is 0.3 m (1 ft) deep (Figure 14). It may be karstic in origin, or it may have an anthropogenic origin related to a nearby natural gas pipeline. Excavation would be needed to make that determination, and was recommended. ROE for excavation purposes was not granted.

Figure 13. Overview of feature 281-009.

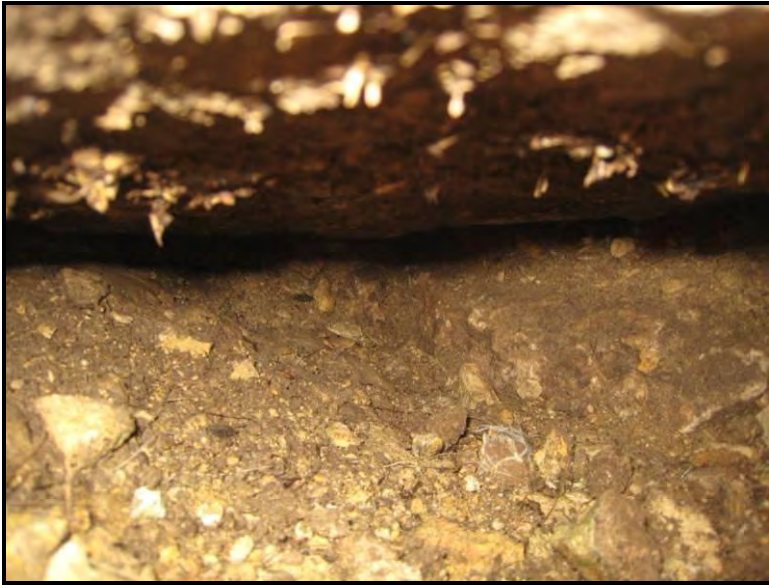
Figure 14. Interior of feature 281-009.

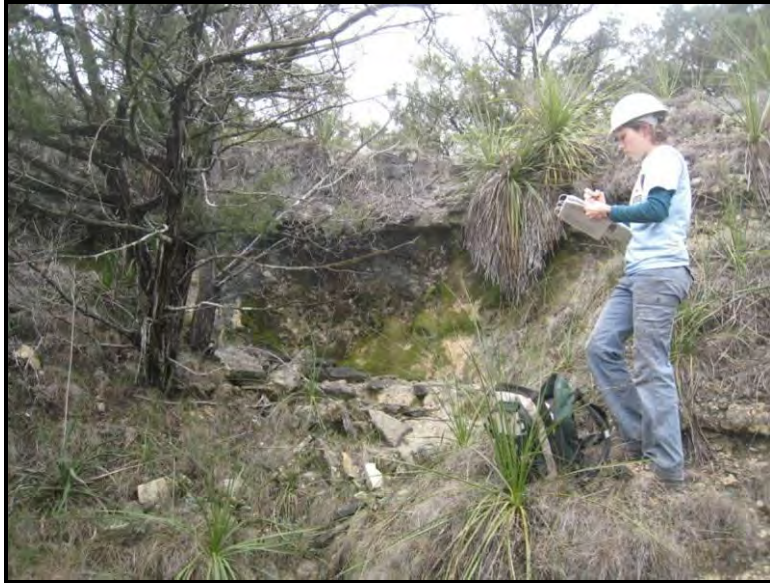
281-010, spring This is a seep spring located on private property on the west side of US 281 (Figure 15). It flows from the travertine-covered base of a 3 m (9.8 ft) tall cliff in an area that is 2 m (6.6 ft) long by 1 m (3.3 ft) wide, but it does not have an identifiable portal (Figure 16). A small amount of water was flowing from it when assessed on 1 March 2010. It is possible habitat for *Eurycea* salamanders, but not likely due to the apparent lack of a portal. It was not sampled for salamanders due to revocation of ROE.

Figure 15. Overview of feature 281-010.

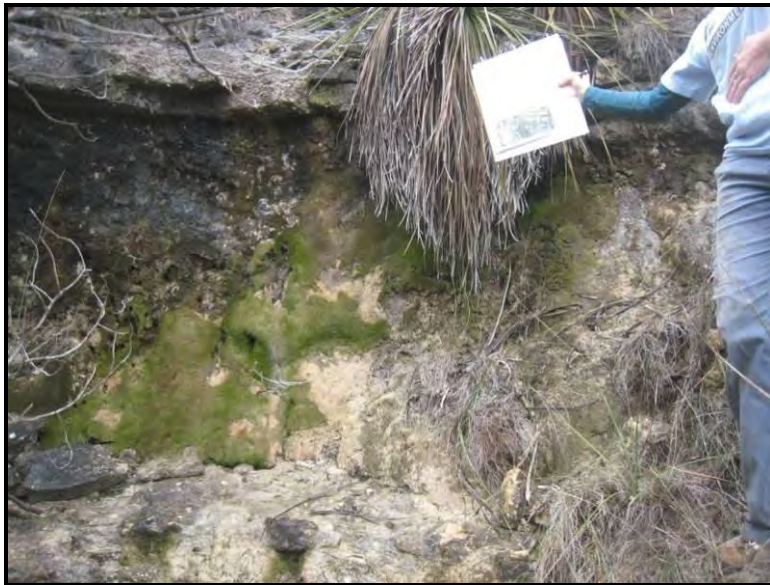
Figure 16. Feature 281-010 exhibits travertine deposition.

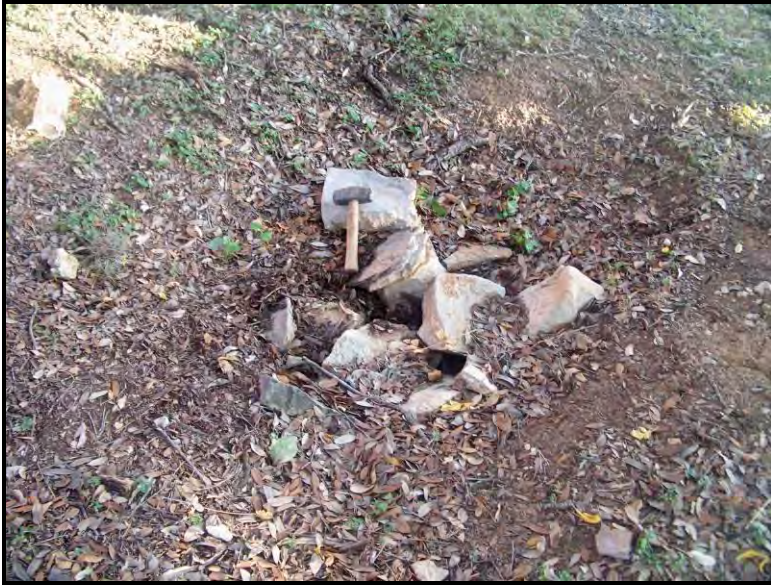
281-011, non-karst closed depression This depression is located on private property between a house and some storage units. When first located it was 1.5 m in diameter and 0.7 m deep, and filled with loose rocks (Figure 17) and snakes. Excavation was recommended to determine its origin. This was conducted on 10 August 2010. During this excavation effort, 9.25 person-hours of effort were expended and 1.25 m³ (44 ft³) of material was removed. This resulted in a rectangular depression 2.5 m (8.2 ft) long, 1.5 m (4.9 ft) wide, and 1 m (3.3 ft) deep, with a floor of hard-packed soil (Figure 18). Trash was removed from this excavation, and a rusty metal pipe leads into it (Figure 19). This feature appears to be some kind of old septic facility, and is not karst-related. A list of fauna encountered in 281-011 can be found in Table 4.

Figure 17. View of feature 281-011 prior to excavation.

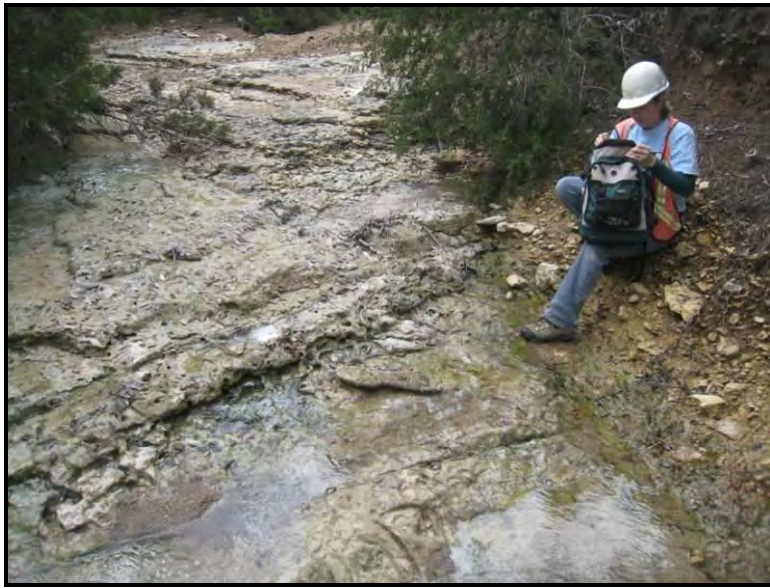
281-012, spring This is a spring that emerges from two small bedrock openings in the middle of a creek bed that are 0.2 m (0.7 ft) in diameter. When the site was recorded on 1 March 2010, water was flowing from both the spring orifices and from upstream in the creek (Figure 20). It is not known if the water coming from the spring is merely pirated from the stream flow nearby, or if it has a more distant source. The spring has a well-defined bedrock orifice (Figure 21), which is possible habitat for threatened *Eurycea* salamanders; however it was not sampled due to revocation of ROE.

Figure 20. Overview of spring 281-012. Two spring outlets are present along the bedding plane that cuts diagonally across the picture.

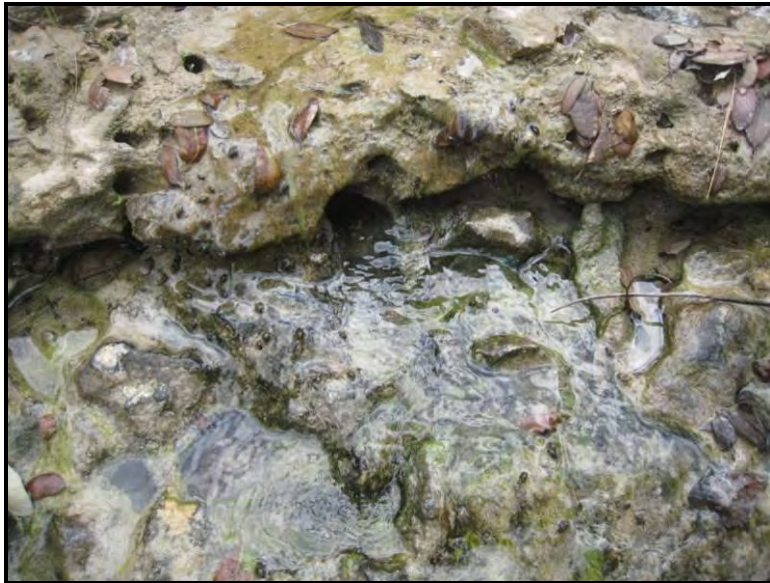
Figure 21. One of two spring outlets at feature 281-012.

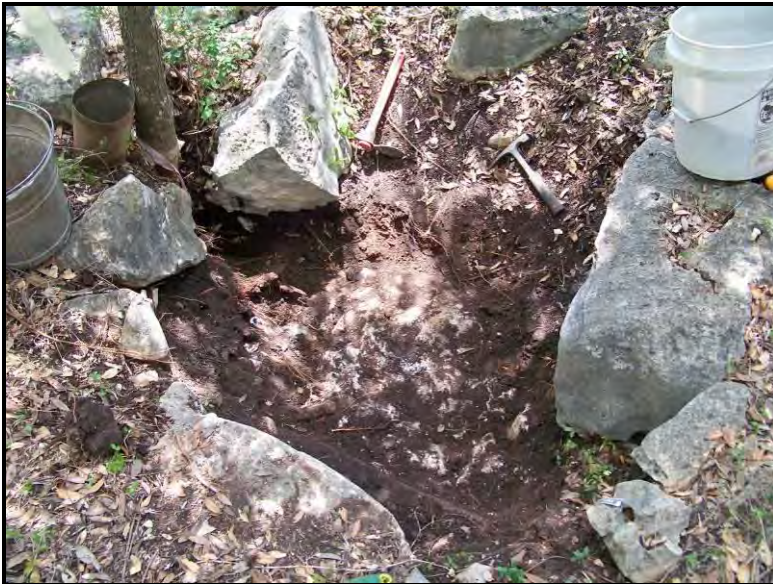
Figure 25. Feature 281-014 after excavation, showing bedrock floor.

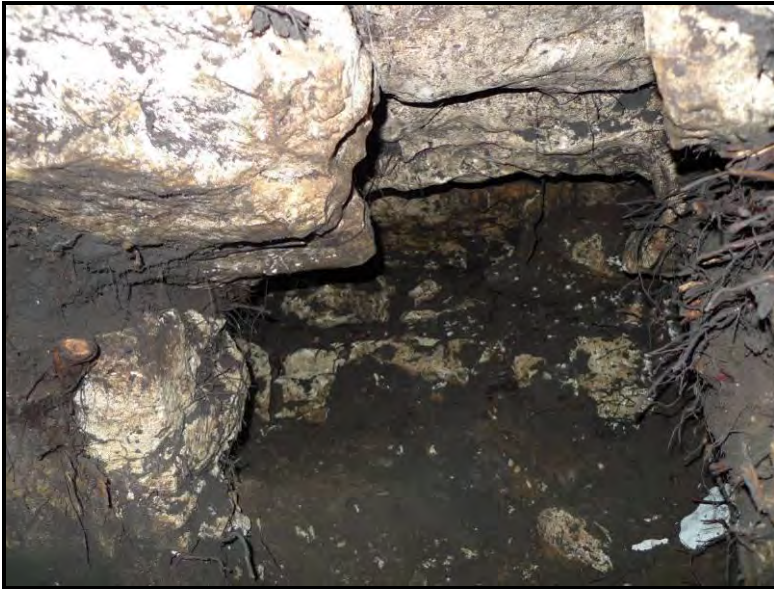
Figure 39. Bottom of feature 281-025 after excavation.

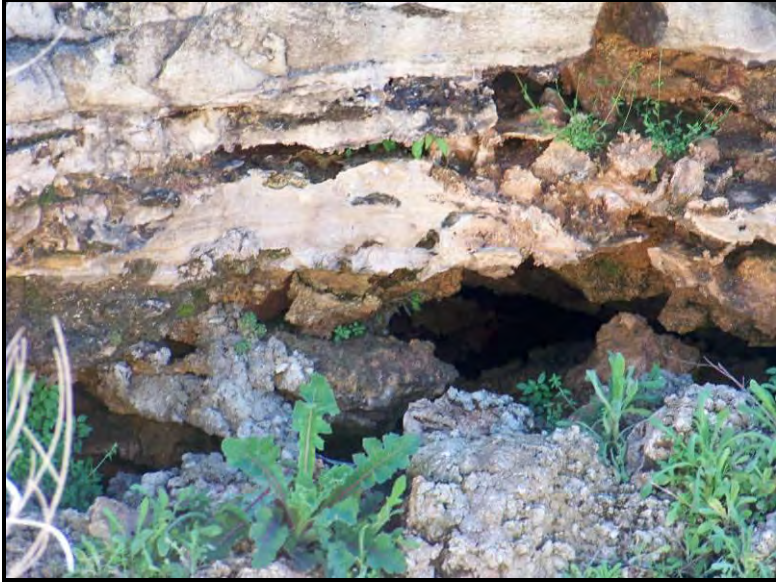
Figure 58. Feature 281-037, which was partially filled with concrete.

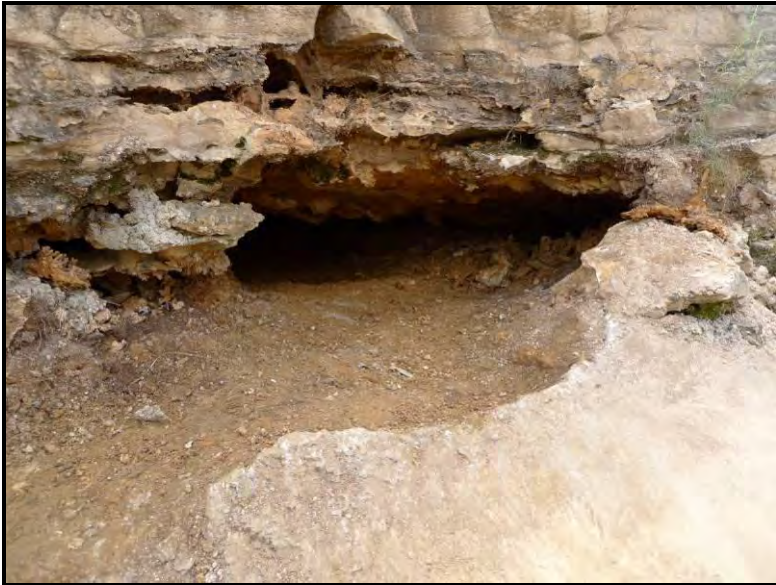
Figure 59. Entrance to feature 281-037 after enlargement by excavation.

281-037, Painful Crawl, cave This is an enlarged bedding plane cave in a road cut associated with a parking lot outside of the ROW. It was partially filled with concrete, but a low passage could be seen extending into the road cut (Figure 58). Excavation was conducted on 15-16 September 2010. This resulted in 2 m³ (106 ft³) of rocks being removed from the cave using 20 person hours of effort with hand and power tools. This cave is developed in a low, wide bedding plane, and is just tall enough for human entry (Figure 59). The bedrock and flowstone floor is rough, giving rise to the name Painful Crawl (Figure 60). Excavation concentrated on removing bits of rock from the floor and ceiling in order to be able to enter the passage, but did not change the existing footprint of the cave. Excavation continued 10 m (32.8 ft) until dark zone habitat was reached. The entrance to Painful Crawl is at the bottom of a sloping road cut that is 3.5 m tall. It is 1.4 m (4.6 ft) wide and 0.4 m (1.3 ft) tall. After 3 m (9.8 ft), the passage takes a turn to the east, with small bedding plane openings also extending off to the south and west at this turn. After

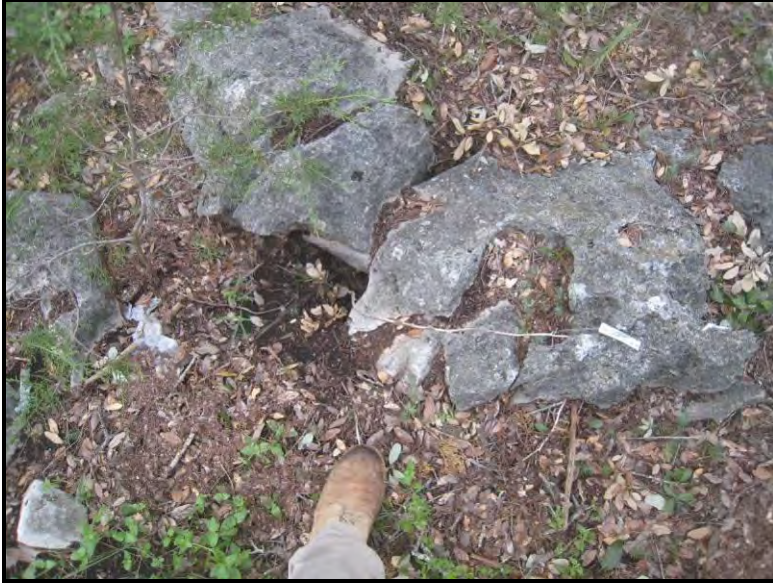
Figure 65. Feature 281-040 prior to excavation.

281-040, non-karst closed depression This feature is located on private property on the west side of US 281. When initially located, it was 1.3 m (4.3 ft) in diameter and 0.3 m (1 ft) deep (Figure 65). It had infill of leaf litter and black, modern soil. Excavation was conducted on 10 September 2010, utilizing 1 person-hour of effort and removing 0.2 m³ (7 ft³) of rocks and soil to a bedrock floor (Figure 66). Post-excavation dimensions of this feature were 1.4 m (4.6 ft) in diameter and 0.6 m (2 ft) deep. This feature is erosional in origin, likely the result of bedding plane slumping on a hillside slope.

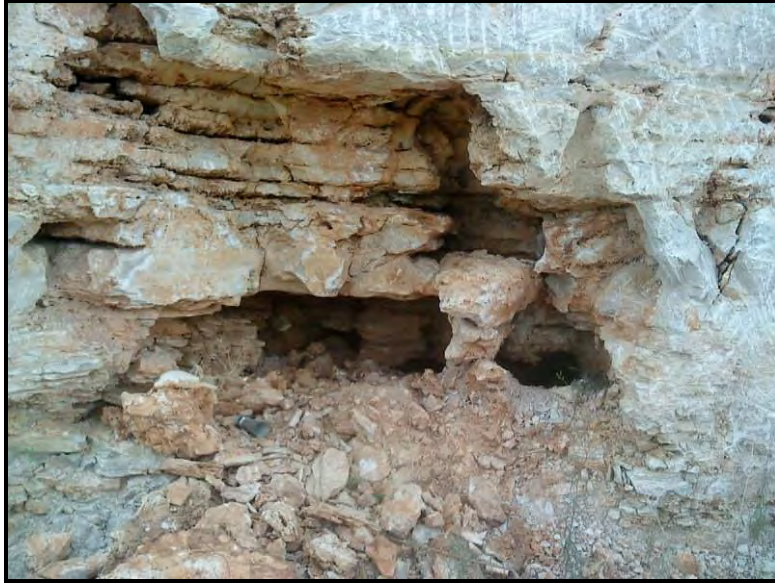
281-055, solution cavity/enlarged bedding plane This feature is an enlarged bedding plane at the base of a construction site road cut on private property. It is 2 m (6.6 ft) wide, 1.7 m (5.6 ft) tall, and extends into the road cut for 1 m (3.3 ft) (Figure 91). It is developed along a fracture bearing 90 degrees. It was recommended for excavation, but ROE for excavation purposes was not granted.

Figure 91. Overview of feature 281-055.

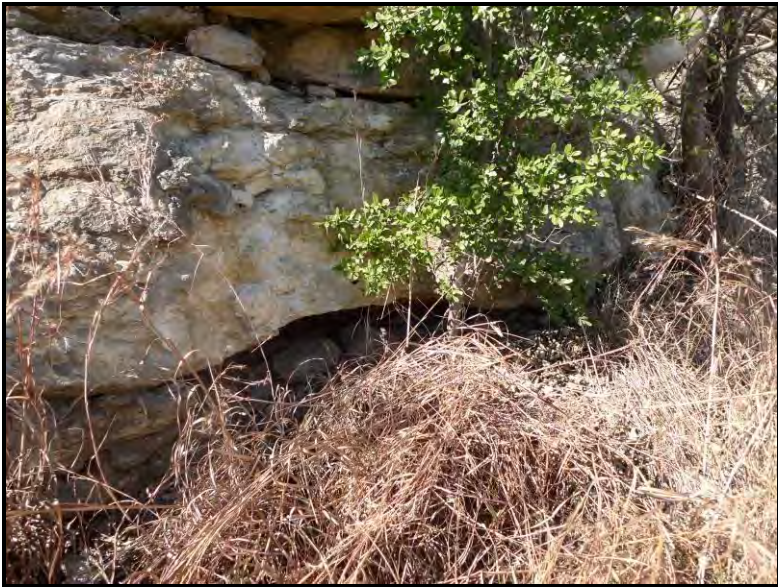
281-060, solution cavity/enlarged bedding plane This is an enlarged bedding plane opening in a road cut on the west side of US 281. It consists of three side by side openings within an area 2.25 m (7.4 ft) wide (Figure 97). They are 0.3 m (1 ft) tall and extend no more than 0.5 m (1.6 ft) into the road cut (Figure 98). This feature was not recommended for excavation (Table 1).

Figure 97. Overview of feature 281-060.

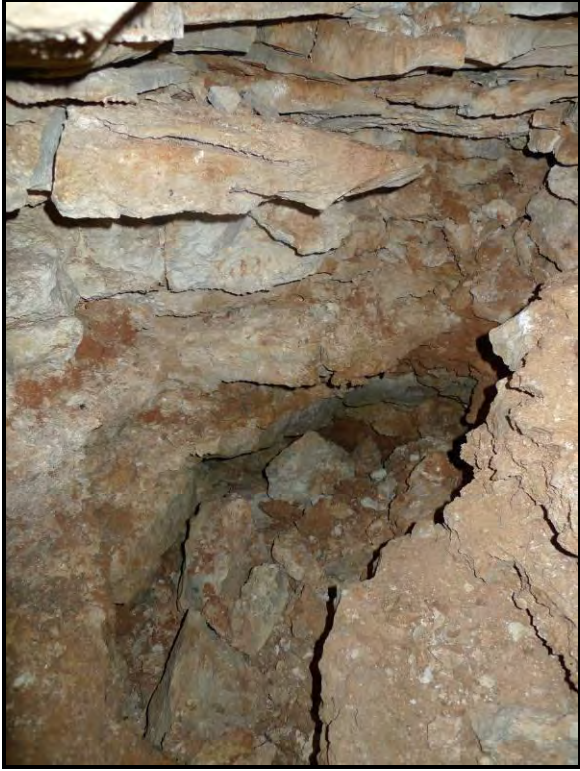
Figure 100. Interior of feature 281-062.

281-062, cave This enlarged bedding plane in the road cut on the west side of US 281 had a 1.9 m wide and 0.75 m high entrance (Figure 99), and extended 2 m (6.6 ft) into the road cut. Excavation was conducted on 3 June 2010, when 3 m³ of material was removed. These rocks were lightly cemented together with calcite, with voids between them. The excavation trended back underneath the roadway with an unstable ceiling, and excavation efforts ceased about 5 m into the feature (Figure 99). Post-excavation dimensions of the cave were 5.4 m long (17.7 ft) by 1.5 m (4.9 ft) wide and 3.4 m (11.1 ft) deep (Figure 101).

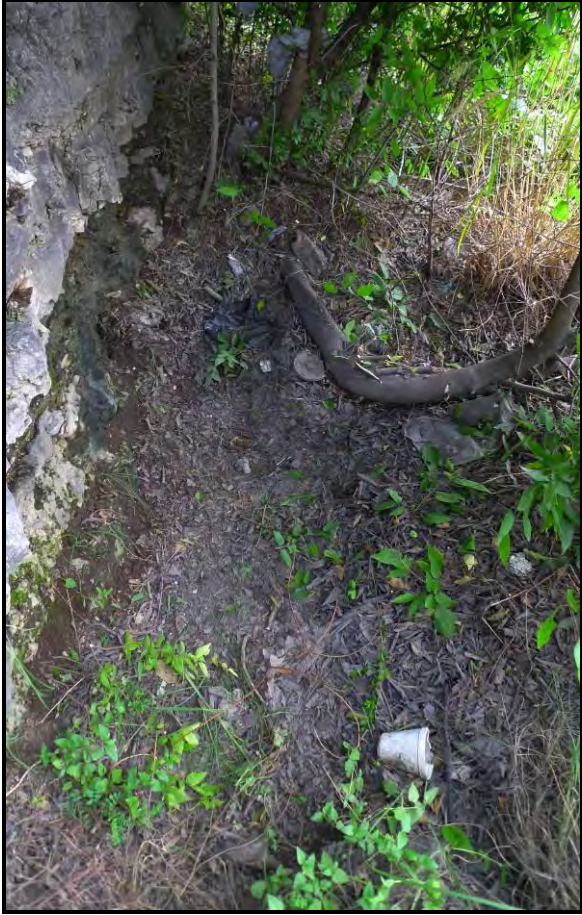
Figure 104. Feature 281-064 prior to excavation.

281-064, non karst closed depression This is a depression at the base of the road cut on the west side of US 281. When initially assessed it was 2 m (6.5 ft) in diameter and 0.3 m (1 ft) deep (Figure 104). It had fine infill of leaf litter and modern soils. It receives sheetwash from a drainage area of 600 m² (6,458 ft²) from the bar ditch. It was excavated on 14 June 2010; 0.05 m³ (1.8 ft³) of material was removed with 2 person hours of labor. Post-excavation dimensions of the feature were 2 m (6.5 ft) in diameter and 1.25 m (4.1 ft) deep. Excavation reached a bedrock bottom with an apparent drain hole. However, this hole is actually a drill hole from the original road cut construction (Figure 105), not part of a karst feature.

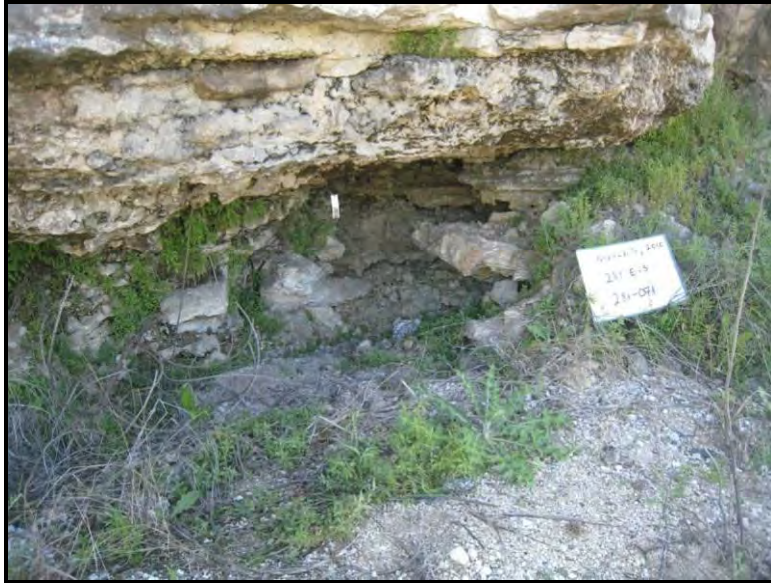
Figure 118. Overview of feature 281-071.

281-071, solution cavity/enlarged bedding plane This feature is located in the east road cut of US 281. It is an enlarged bedding plane with an entrance that is 2 m (6.6 ft) wide and 1 m (3.3 ft) high (Figure 118). It extended for 3 m (9.8 ft) into the road cut, with a small hole continuing on (Figure 119). Previous excavation has occurred here, as evidenced by a tailings pile just outside of the entrance. It was excavated on 16 June 2010. About 1 m³ (35 ft³) of rock was removed from the back of the feature, which was a bedding plane shelf with small openings continuing on (Figure 120). Further excavation effort would have required intense bedrock mining. Given that it was developed in the same bedding plane as the sample-able habitat in Stafford Cave and Cool Cave on either side of it, further excavation efforts were not deemed worthwhile. The post-excavation dimension were 3 m (9.8 ft) long by 2 m (6.6 ft) wide bay 1.3 m (4.3 ft) deep. One troglobite (*Brackenridgia* sp.) was encountered during excavation, so presence/absence surveys were performed.

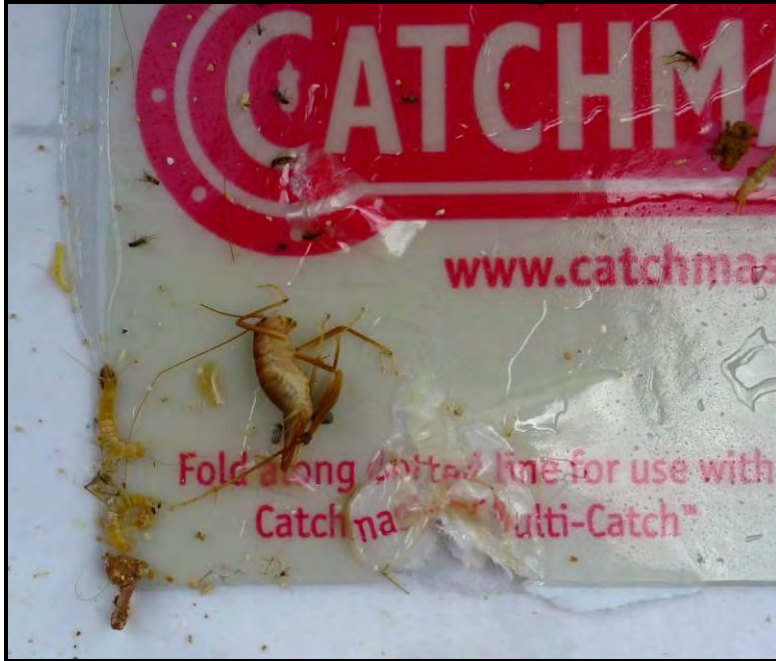
Figure 126. Glue trap retrieved from Cool Cave containing *Texoreddellia* subterranean silverfish and *Ceuthophilus cunicularis* cave crickets.

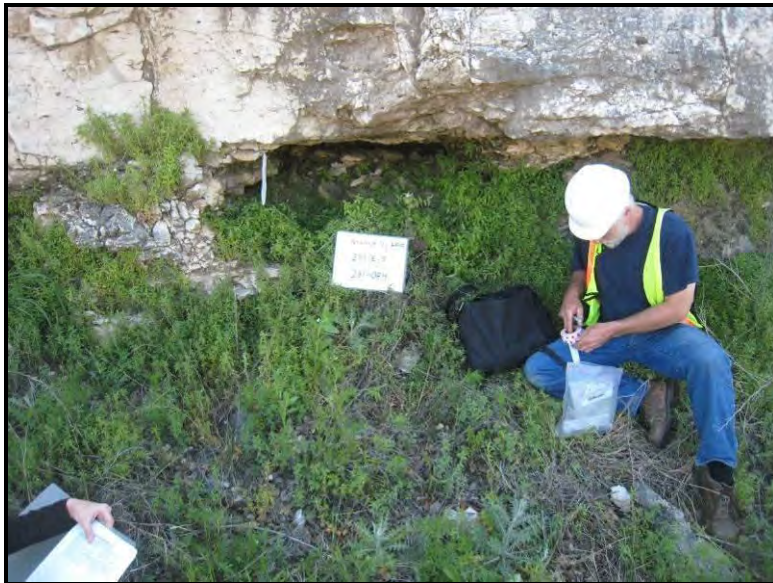
Figure 127. Overview of feature 281-074.

281-074, solution cavity/enlarged bedding plane This enlarged bedding plane opening is in the road cut on the east side of US 281 (Figure 127). It is 1 m (3.3 ft) wide, 0.3 m (1 ft) tall, and extends into the road cut for 1 m (3.3 ft) (Figure 128). This feature was not recommended for excavation (Table 1).

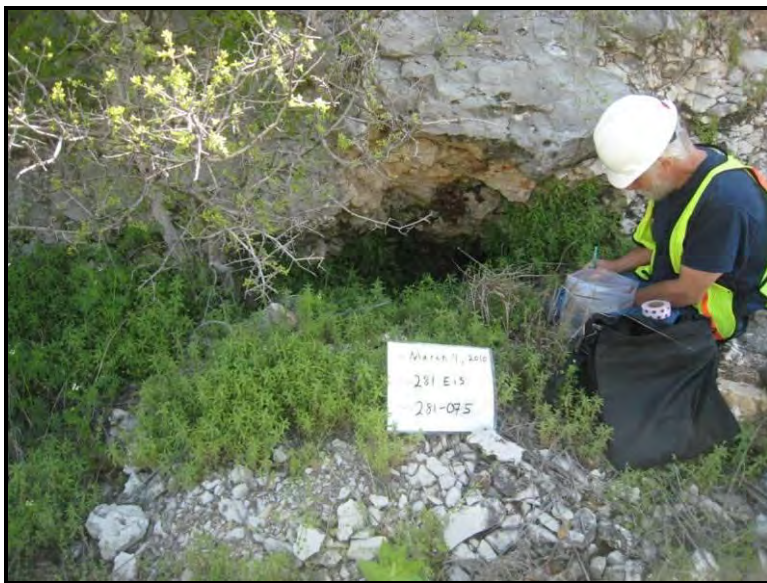
Figure 129. Overview of feature 281-075.

281-075, solution cavity/enlarged bedding plane This feature is an enlarged bedding plane developed in the east road cut of US 281. When initially assessed it was 1 m (3.3 ft) wide, 0.4 m (1.3 ft) tall, and extended into the road cut for 1.5 m (4.9 ft) (Figure 129). It contained black, modern soil, rocks, and leaf litter. This feature receives channelized flow from the highway bar ditch. The troglophile meshweaver spider *Cicurina varians* was found in this feature. Excavation was conducted on 15 June 2010. Eight person hours of effort utilizing hand tools resulted in the removal of 1 m³ (35 ft³) of material. This resulted in the enlargement of the entrance to 1.5 m (4.9 ft) in diameter, and the floor was lowered to 1 m (3.3 ft) below the elevation of the bar ditch for a total depth of 2 m (6.6 ft). The floor was composed of clay that extended up the walls to meet the bedrock ceiling, with no voids visible (Figure 130).

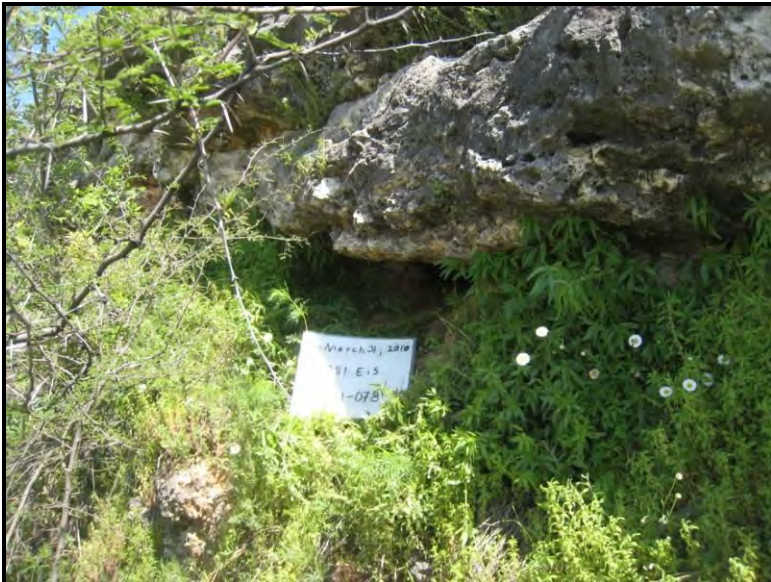
Figure 135. Overview of feature 281-078.

281-078, solution cavity/animal burrow This feature is located in the east road cut of US 281. It is an enlarged bedding plane with an entrance that is 0.4 m (1.3 ft) wide and 0.2 m (0.7 ft) high. It extends at least 1.5 m (4.9 ft) into the road cut with a continuing void, and has slight airflow (Figure 135). It was excavated on 21 June 2010. Utilizing 6 person-hours of labor, 1 m³ (35 ft³) of material was removed; no continuing voids were seen (Figure 136). Post-excavation dimensions of the feature were 1.5 m (4.9 ft) long by 1 m (3.3 ft) wide by 0.5 m (1.6 ft) deep. The only fauna observed in this feature were two centipedes, one in the order Geophilomorpha and the other in the order Lithobiomorpha (family Lithobiidae). This feature appears to be an animal burrow.

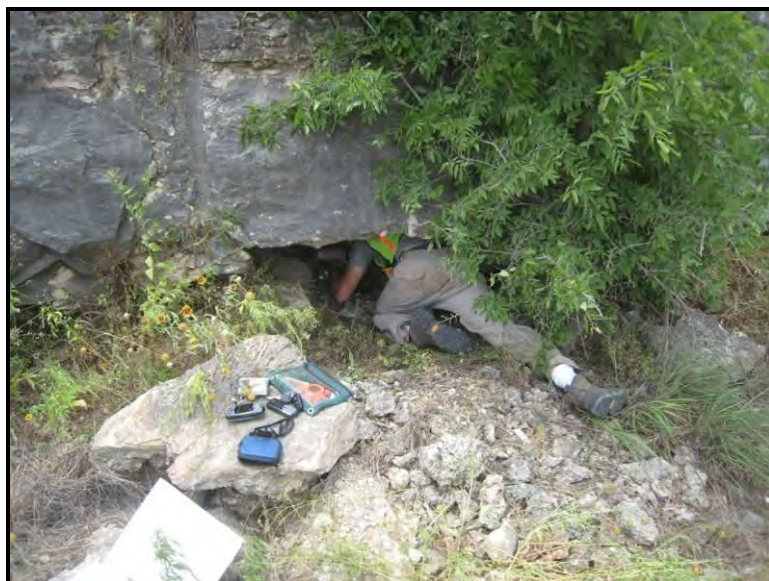
Figure 150. Exterior of feature 281-083.

281-083, Dripstone Cave This cave is located in the western road cut of US 281, to the south Marshall Road. It is formed in an enlarged bedding plane. Two entrances 3 m (9.8 ft) apart join up as a wide, low bedding plane void that was likely formed under phreatic⁵ conditions (Figure 150). The cave is 13 m (42.7 ft) long by 5 m (16.4 ft) wide by 1 m (3.3 ft) deep. This cave is located at the very base of the road cut, and receives channelized recharge from the bar ditch. The entrance had been previously excavated. The walls and ceiling of this cave are mostly covered in calcite, which gave rise to the name Dripstone Cave (Figure 151). The floor is covered in loose, calcite-encrusted rocks. There is little organic debris, apart from some mammal scat. Several small voids extend off of the back of the cave (Figure 152). Biological surveys on this feature were conducted on 14, 21, and 29 June and 9 and 16 September 2010. A complete list of fauna encountered in 281-083 is included as Table 25.

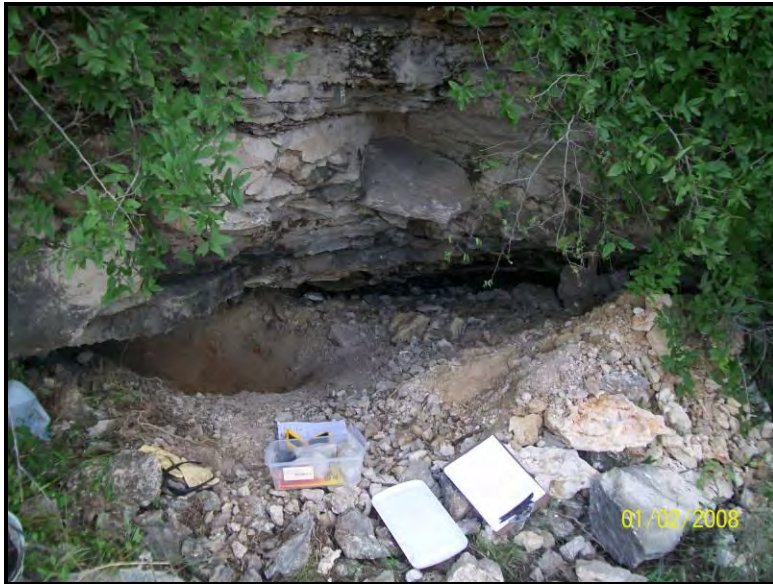
Figure 155. Overview of feature 281-085.

281-085, solution cavity/enlarged bedding plane This feature is located in the western road cut of US 281, to the south Marshall Road. It is formed in an enlarged bedding plane at the base of the road cut, and it takes channelized drainage from the bar ditch (Figure 155). The entrance is 4 m (13.1 ft) wide and 2 m (6.6 ft) tall. When initially assessed it quickly became too low to enter, but extended at least 3 m (9.8 ft) into the road cut and was considered to be potentially humanly-enterable. Excavation was conducted on 18 June 2010 for 6 person hours, removing 0.75 m³ (26.5 ft³) of material from the feature. The floor was lowered, enabling the back of the feature to be examined. Post-excavation dimensions of the feature were 4 m (13.1 ft) in width and 2.5 m (8.2 ft) in height and extended 3 m (9.8 ft) into the road cut. No voids continued on (Figure 156), but the detection of troglobitic species during excavation prompted the initiation of presence/absence surveys. Biological surveys on this feature were conducted on 25 June and 1, 9, and 16 September 2010. A complete list of fauna encountered in 281-085 is included as Table 28.

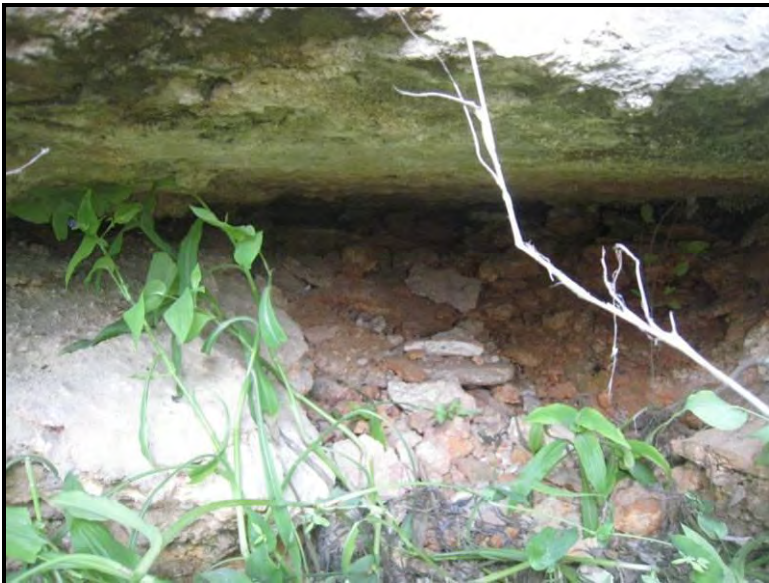
Figure 158. Interior of feature 281-086.

281-086, solution cavity/enlarged bedding plane This feature is located in the western road cut of US 281, to the south Marshall Road. It is formed in an enlarged bedding plane. The entrance is 2 m (6.6 ft) wide and 0.45 m (1.5 ft) high (Figure 157). It extends 1 m (3.3 ft) into the road cut, at which point a small portal that is not humanly-enterable continues for an unknown distance (Figure 158). It is formed at the base of the road cut, taking channelized drainage from the bar ditch. Previous excavation has occurred here, as evidenced by a tailings pile just outside of the entrance. This feature was not recommended for additional excavation (Table 1).

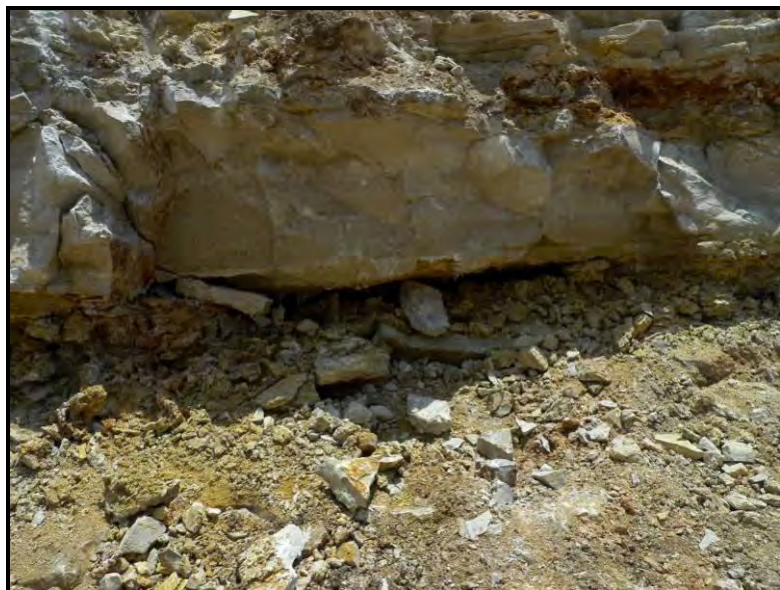
Figure 164. Entrance to feature 281-089 prior to excavation.

281-089, Zombie Cave This karst feature is located in the road cut just south of Zombie Cave, and upon excavation and investigation was found to connect to it (Figure 164). See the description of 281-088 for more information.

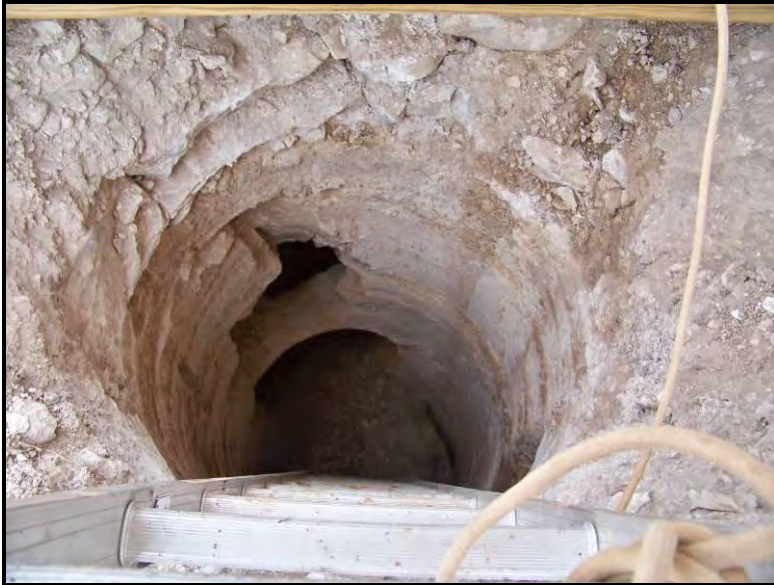
Figure 166. View down drilled shaft at feature 281-090 after excavation.

281-090, solution cavity In August 2010 a construction team working on the installation of a traffic signal at the intersection of Evans Road and 281 encountered a karst feature while drilling a 1 m (3.3 ft) diameter foundation (Figure 165). Excavations were conducted on 25 and 26 August 2010 to remove drilling rubble in order to assess the void for karst invertebrate habitat (Figure 166). The drilled shaft was 3 m (9.8 ft) deep, with the void extending off of the north wall. The opening into the void extended from the floor of the shaft at -3 m (-9.8 ft) to a point 1.6 m (5.2 ft) above that. The total vertical extent of the void was 3 m (9.8 ft), with tiny voids extending off of the top and bottom of it. Post-excavation dimensions of the feature were 2 m (6.6 ft) long by 2.5 m (8.2 ft) wide and 3 m (9.8 ft) deep. Most of the surfaces within the void were encrusted with calcite, including the floor drain which effectively plugged it (Figure 167). Although the feature did not necessarily meet all of the guidelines presented in USFWS (2006) for warranting excavation or subsequent presence/absence surveys, a troglobitic species (*Texoreddellia* sp.) was encountered during excavation, prompting the initiation of presence/absence surveys, which were carried out on 1, 9, and 16 September 2010. A complete list of fauna encountered in 281-090 is included in Table 32. A map is presented in Figure 168.

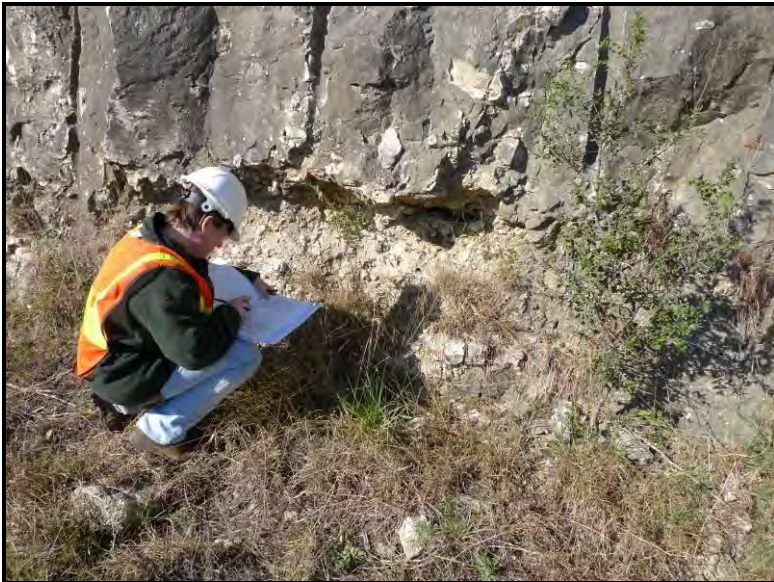
Figure 178. Overview of feature 281-102.

281-102, solution cavity/enlarged bedding plane This feature is located in the west road cut of US 281. The entrance to it is 0.3 m (1 ft) in diameter, and it extends into the road cut for 0.3 m (1 ft) (Figure 178). It has a coarse infill of loose rocks (Figure 179). This feature was not recommended for excavation (Table 1).

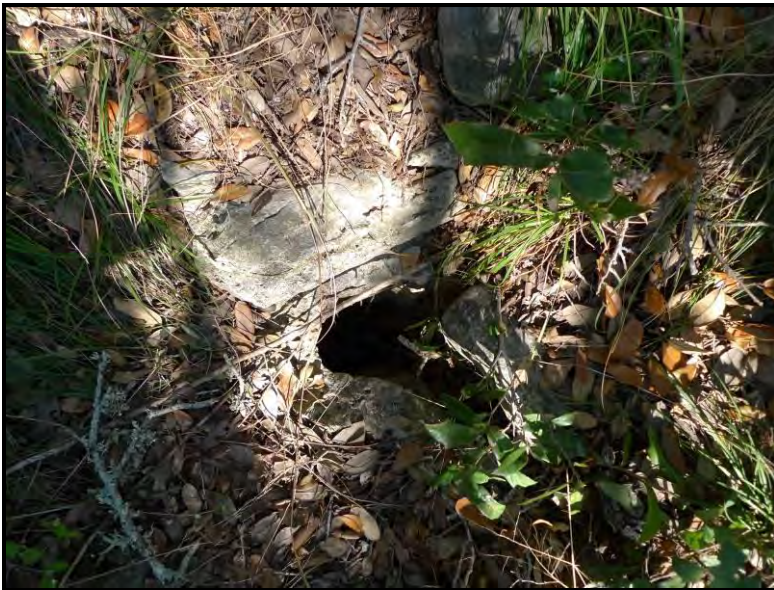
Figure 180. Overview of feature 281-103.

281-103, solution cavity This feature is located on private property on the west side of US 281 (Figure 180). The entrance is 0.25 m (0.8 ft) wide, 0.2 m (0.7 ft) long, and when initially assessed it dropped 0.4 m (1.3 ft) to a floor composed of organic debris and soil that was loose to a depth of loose. Preliminary excavation lowered the floor 0.1 m (0.15 ft), but more excavation would have required removal of some of the bedrock walls (Figure 181). This was recommended, but ROE for that purpose was denied.

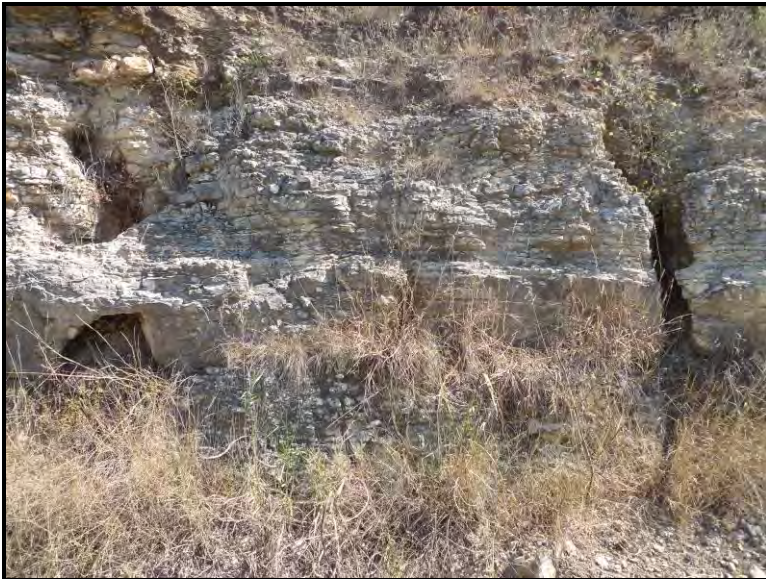
Figure 182. Overview of feature 281-104.

281-104, solution cavity This consists of two solution cavities in the east US 281 road cut, one of which is associated with a fracture (Figure 182). The north cavity is 0.8 m (2.6 ft) wide, 1.2 m (3.9 ft) tall, and extends into the road cut for 0.2 m (0.7 ft). The south cavity is 0.4 m (1.3 ft) wide, 1.3 m (4.3 ft) tall, and extends into the road cut for 0.7 m (2.3 ft). These contain coarse infill of rocks that is likely a consequence of road cut excavation (Figure 183). This feature was not recommended for excavation (Table 1).
